MARK WELBY
CONSULTING ARBORISTS

Tree Condition Assessment

Hollowdene Recreation Ground & Shortfield Common

Reference: MW.2401.FRP.TCA2026
Client: Frensham Parish Council
Date: 19 February 2026

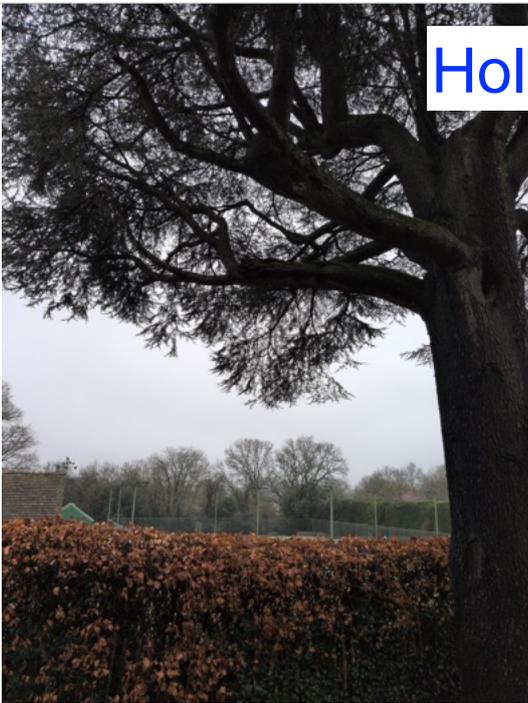
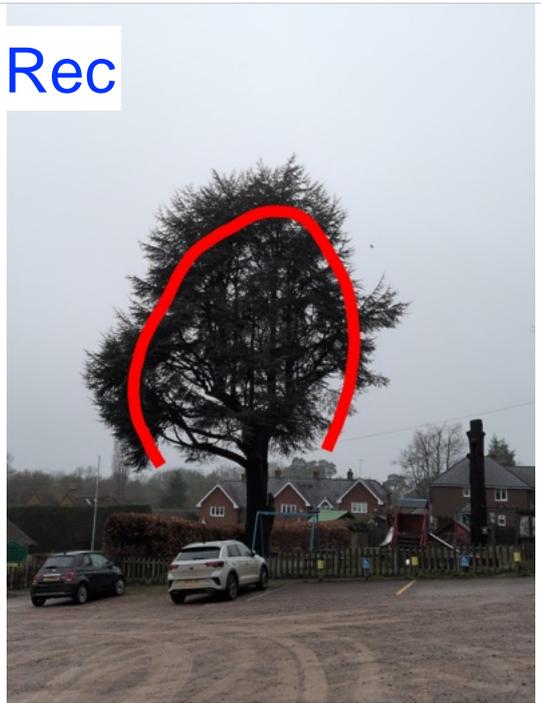
815 P004

Ref	Species	Stem Diameter (est cm)	Height (est m)	Survey Notes	Recommendations*	What3Words**	Priority
815	Blue cedar	110	18	Lowest South easterly limb has historic wound on top of it. Approximately 2 m in length. Branch has been reduced in length in the past. No obvious signs of weakness or movement at the wound point. Tree has been historically reduced, and many new leaders have potential to fail in the future.	Reduce height of tree by approximately 3 m and radial spread by approximately 2 m. The reason is to contain size and minimise the chance of future branch failure due to sub-optimal form arising from unsympathetic past reductions. See photograph for approximate reduction size. Pruning should be limited to small lateral branches and could be carried out with a handsaw or loppers. Work to larger diameter branches should be minimised.	///cobbles.smuggled.opponent	Medium (<12 months)
819	Pedunculate oak	75	18	No change since last survey.		///times.golden.surround

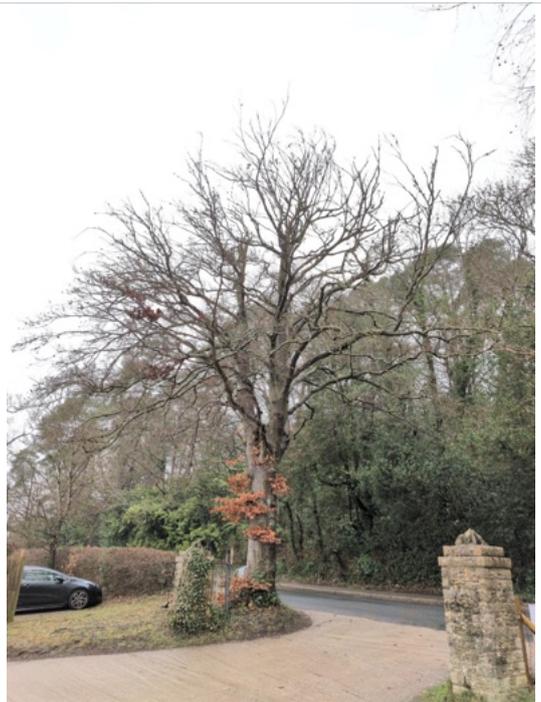
822 P002

822	Common beech	65	11	Significant quantity of dead wood and die back in crown. Consistent with extensive physiological stress and dysfunction. Tree located in high occupancy area	Remove tree	///loser.plump.link	High (<3 months)
823	Common beech	35	12	Small tree - no noteworthy issues.	Lift crown over car park to give a 5 m clearance	///initiates.even.crockery	Low (Recommendation)
824	Norway maple	45	11	No noteworthy issues.		///rainfall.repeat.inched	
825	Pedunculate oak	70	13	No obvious changes since last survey	Lift crown over car park to give 5 m clearance	///airports.magicably.pound	Low (Recommendation)
826	Common beech	60	11	No noteworthy issues.	Lift crown over car park to give 5 m clearance	///petal.overhear.editor	Low (Recommendation)
827	Common beech	95	16	No obvious changes since the last survey		///roadblock.areas.glee

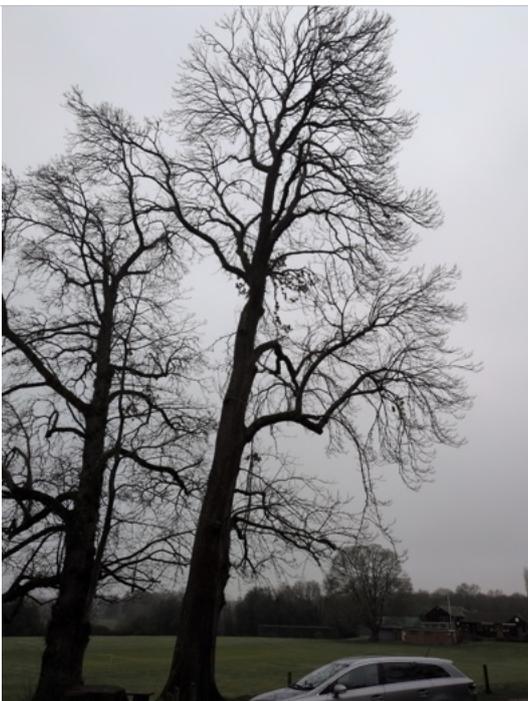
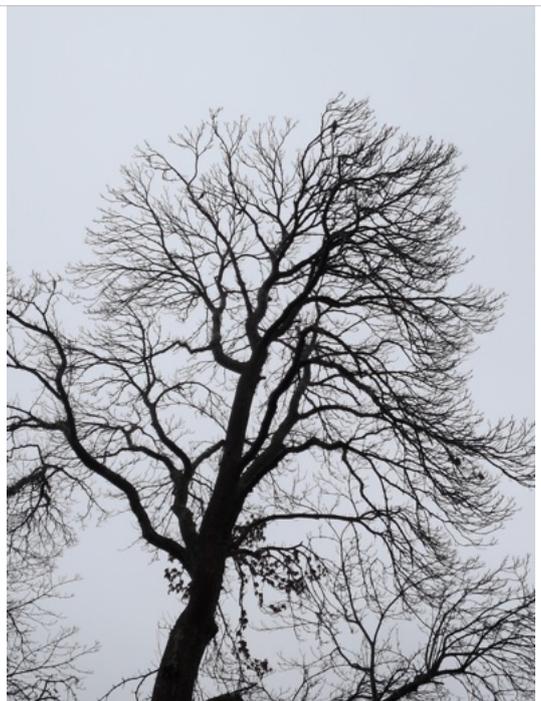
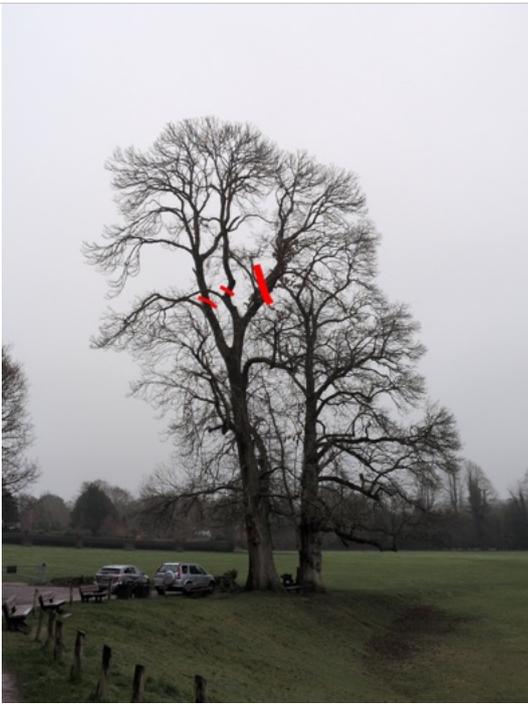
828 P002

Ref	Species	Stem Diameter (est cm)	Height (est m)	Survey Notes	Recommendations*	What3Words**	Priority
828	Sweet chestnut	110	23	Upper crown is starting to look somewhat impoverished. There is prolific shoot growth along most of the upper branches and limited fine twig reiteration in the outer and upper crown. The tree is over the parking area: probably the most heavily trafficked zone on the site. The structure of the main stem and branches do not offer an optimal reduction point. Therefore, the proposed reduction is more extreme than they would prefer but appropriate given the location of the tree	Reduce height of tree to approximately 16 m. See photograph for suggested cut area. At this time we will avoid pruning the retained branches, albeit they will mean the remaining tree is somewhat asymmetric. There is enough strength in the main stem to tolerate this. Further pruning work will be reviewed in next cycle	///pheasants.knees.modern	Medium (<12 months)

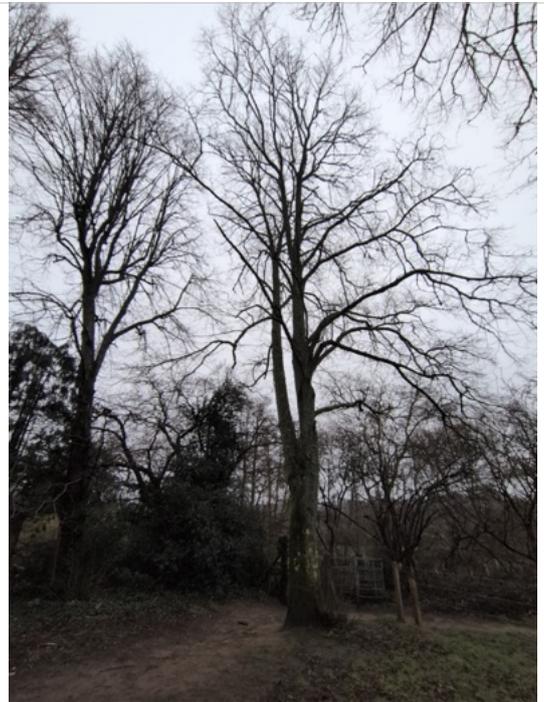
860 P001

Ref	Species	Stem Diameter (est cm)	Height (est m)	Survey Notes	Recommendations*	What3Words**	Priority
859	European lime	70	17	High pollard form. Now regrown.		///describe.reviewed.recur	
860	Lime	70	22	Deadwood and branches over footpath	Remove any poorly attached. Dead wood over footpath	///umbrella.saunas.zaps	Medium (<12 months)
861	Lime	70	22	No noteworthy issues or features.		///library.onlookers.tables	
862	Lime	70	22	No noteworthy issues or features.		///awestruck.clashing.poets	
863	Lime	70	22	No noteworthy issues or features.		///happily.tasteful.flinch	
864	Scots pine	70	13	No noteworthy issues or features		///alienated.formed.shepherds	
866	Lime	70	22	No noteworthy issues or features.		///homecare.tequila.seducing	
867	Lime	30	6	Group of stems. Regrowth from stump.		///assume.typically.waxing	
869	Sycamore	50	15	Twin stems. No noteworthy issues or features		///glitter.shameless.lofts	
870	Horse chestnut	30	6	Small tree - no noteworthy issues.		///boomer.blushed.shortens

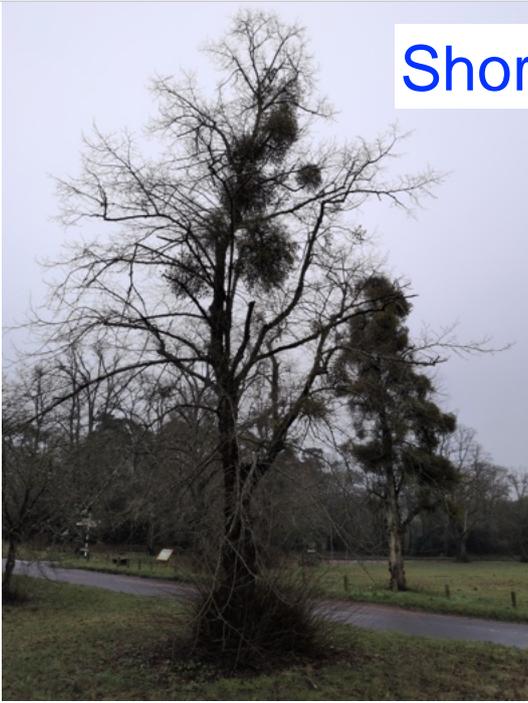
892 P001

Ref	Species	Stem Diameter (est cm)	Height (est m)	Survey Notes	Recommendations*	What3Words**	Priority
887	Pedunculate oak	80	11	No noteworthy features or issues		///monkey.magnitude.existence	
888	Pedunculate oak	60	9	No obvious risk features or issues		///enacted.advice.obstruct	
889	Lime	60	9	No obvious issues		///basics.blackbird.instead	
890	Lime	25	8	No noteworthy features or issues		///continues.rocked.hazelnuts	
891	Lime	20	5	No noteworthy features or issues		///pokers.curving.accordion	
892	Lime	50	12	Mistletoe and deadwood	Remove any epicormic growth at stem base. Thin out or remove mistletoe	///calculate.herds.storming	Low (Recommendation)
893	Lime	40	10	Dieback and mistletoe	Remove any epicormic growth at stem base. Thin out or remove mistletoe	///quaking.commuters.clots	Low (Recommendation)
894	Lime	40	9	Mistletoe becoming dominant. Some epicormic growth	Remove any epicormic growth at stem base. Thin out or remove mistletoe	///loaning.revamping.spouting	Low (Recommendation)

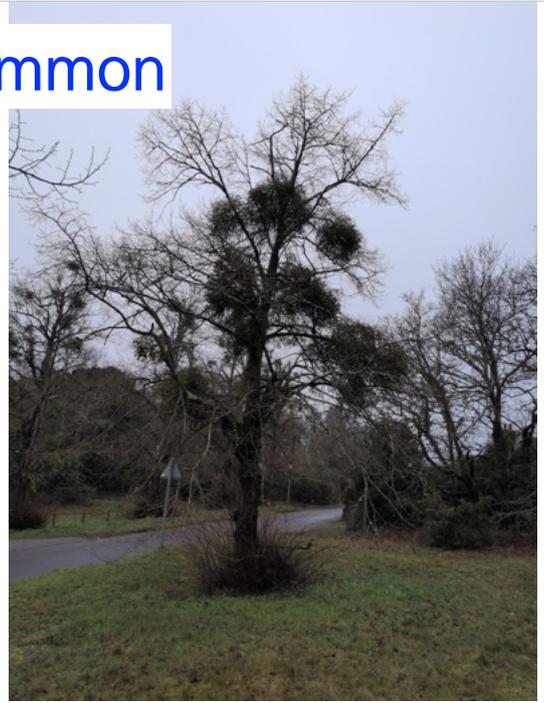
896 P001

895	Lime	30	6	Tip dieback. Deadwood.	Remove any epicormic growth at stem base.	///veal.carver.inserting	Low (Recommendation)
896	Lime	50	10	Some mistletoe and basal growth.	Remove any epicormic growth at stem base. Thin out or remove mistletoe	///weary.into.clots	Low (Recommendation)
898	Pedunculate oak	15	6	Group of four stems. Growing under offsite oak.		///warbler.baths.desk	
901	Lime	40	13	No noteworthy features or issues	Remove basal growth and stem growth to 3 m	///dumpling.composts.exist	Low (Recommendation)
902	Lime	60	17	No noteworthy features or issues	Remove basal growth	///truffles.recur.stumble	Low (Recommendation)

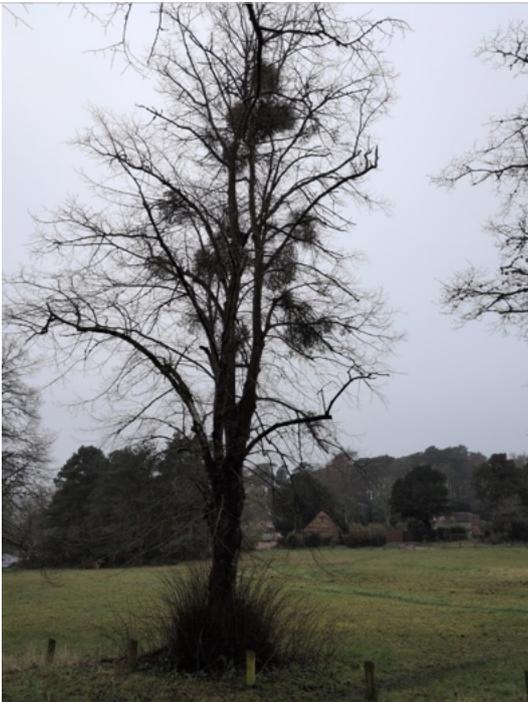
920 P001

920	Lime	60	17	Scattered dead wood. Mistletoe becoming established	Remove basal growth. Remove pulley attached. Dead wood and thin out mistletoe	///swung.mysteries.eternity	Medium (<12 months)

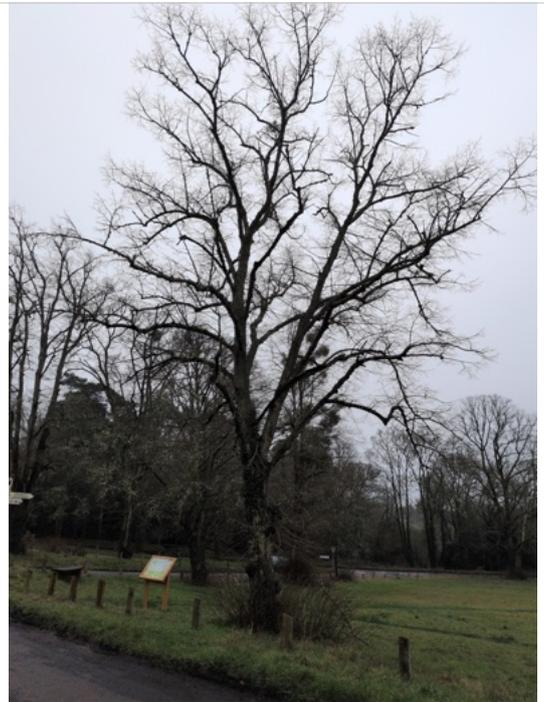
922 P001

Ref	Species	Stem Diameter (est cm)	Height (est m)	Survey Notes	Recommendations*	What3Words**	Priority
921	Lime	45	11	Obvious risk features or issues	Remove basal growth	///nail.readings.icebergs	Low (Recommendation)
922	Lime	60	14	Profuse epicormic growth.	Remove basal growth and any poorly attached dead wood over highway	///emporium.choppers.factories	Medium (<12 months)
923	Lime	50	14	Profuse mistletoe	Remove any epicormic growth at stem base. Thin out or remove mistletoe. Remove any poorly attached. Dead wood	///decays.solids.alike	Low (Recommendation)
924	Lime	40	12	Profuse epicormic growth. Some mistletoe.	Remove any epicormic growth at stem base. Thin out or remove mistletoe	///decisions.fries.enchanted	Low (Recommendation)
925	Lime	50	12	Stem topped at 5 m since last survey. Still alive with some regrowth. Profuse epicormic growth		///foods.seatbelt.souk	
926	Lime	50	13	Profuse epicormic growth.	Remove any epicormic growth at stem base. Thin out or remove mistletoe	///file.notice.sonic	Low (Recommendation)

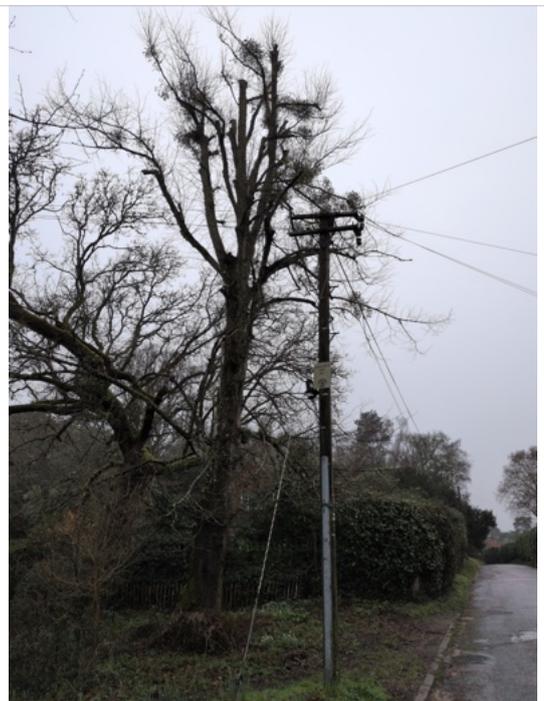
929 P002

927	Lime	50	15	Profuse epicormic growth.	Remove any epicormic growth at stem base. Thin out or remove mistletoe	///moderated.joggers.cherish	Low (Recommendation)
928	Lime	60	16	Profuse epicormic growth	Remove any epicormic growth at stem base. Thin out or remove mistletoe	///shields.apart.bombshell	Low (Recommendation)
929	Lime	60	17	Recently somewhat crudely reduced. Unclear as to why this work was carried out; in my last assessment it had scattered deadwood.	Remove or thin out mistletoe	///encrusted.think.starting	Low (Recommendation)
930	Lime	60	14	No obvious risk features or issues		///excuse.scrubbing.courage	
931	Lime	50	18	No noteworthy features or issues	Remove basal growth	///workshops.talkative.dignify	Low (Recommendation)
932	Lime	60	18	No obvious risk features or issues	Remove basal growth	///change.shackles.listings	Low (Recommendation)
933	Lime	50	19	No noteworthy features or issues	Remove basal growth	///jogged.reddish.youths	Low (Recommendation)

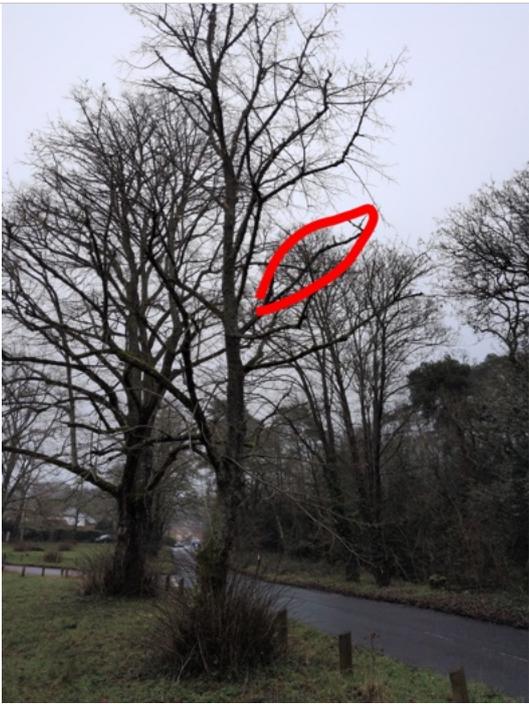
934 P001

934	Lime	40	15	One dead branch with potential to fail into highway	Remove basal growth and poorly attached deadwood over highway	///biggest.gossiping.wizard	Low (Recommendation)
935	Lime	90	19	Scattered dead wood over the highway	Remove basal growth and poorly attached dead wood over the highway	///copiers.backswing.excuse	Medium (<12 months)
936	Pedunculate oak	55	15	Epicormic growth on stem.		///richly.downsize.crass	
937	Scots pine	55	16	No noteworthy features or issues		///fitter.maple.mirroring
